## AERODYNAMIC SIMULATION TESTS OF RSI PANELS

F.J. Centolanzi, N.B. Zimmerman, M.A. Covington, and F.H. Nichols

Ames Research Center  
Moffett Field, California

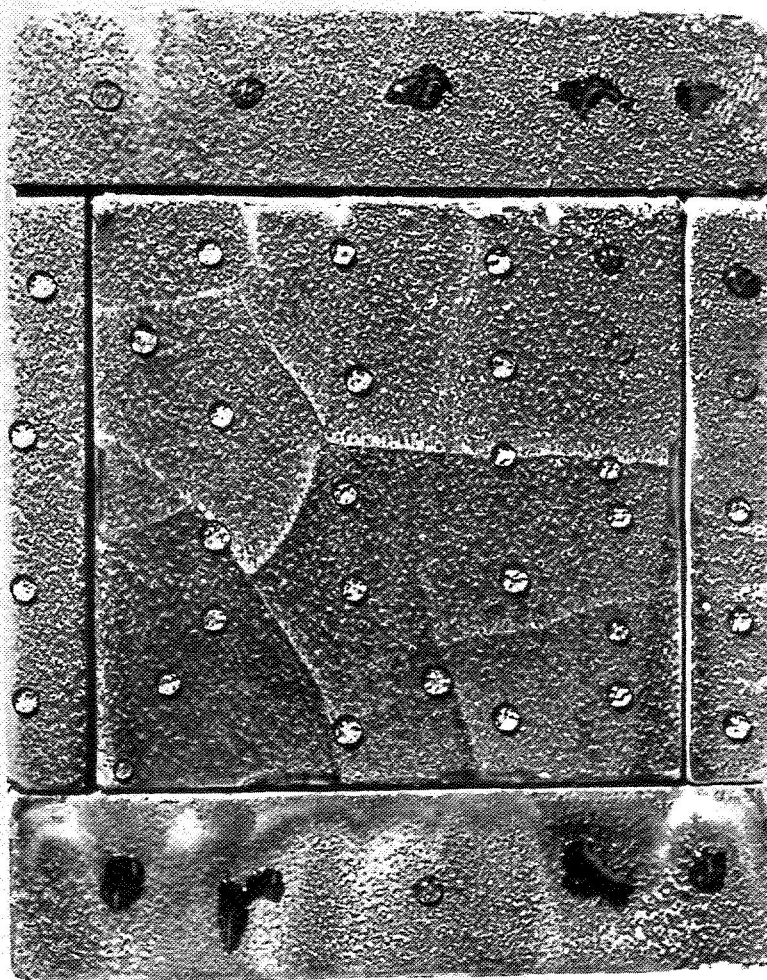
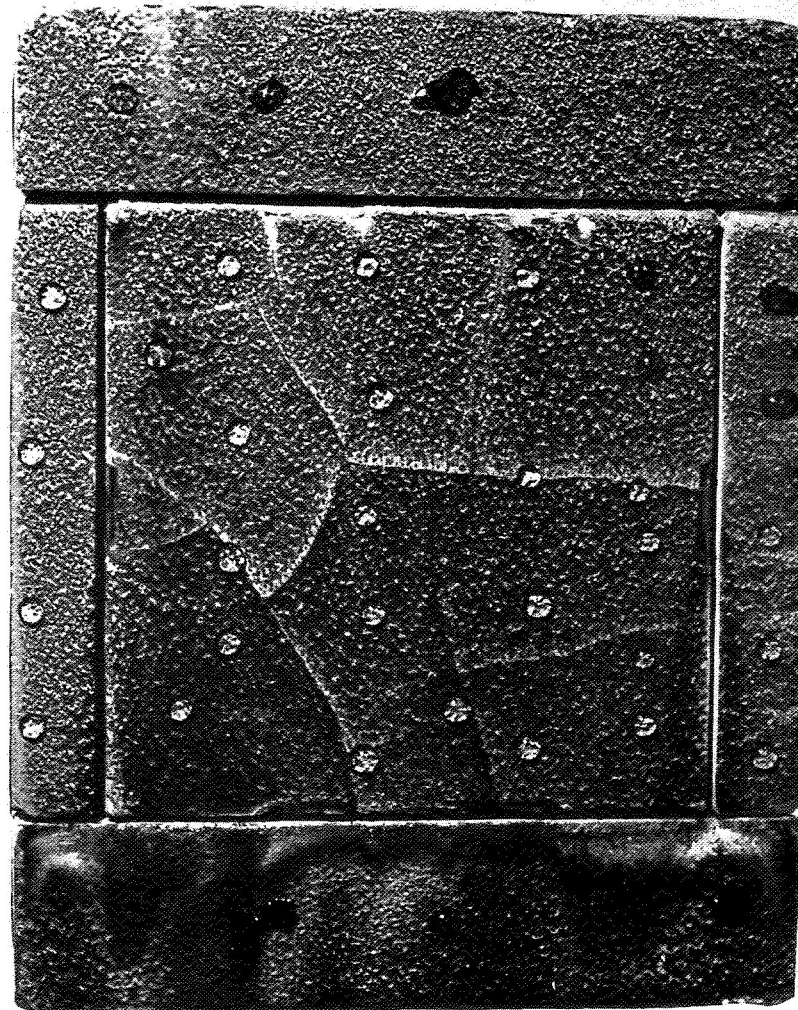
Figure 24

The McDonnell Douglas HCF MOD-III panel shown in this figure showed no signs of absorbing water, even when the droplets were placed over visible cracks.

# WATER REPELLENCY TEST OF McDONNELL DOUGLAS PANEL
